EWB Sheffield Report 2015 - Small Scale Irrigation in Nkhata Bay, Malawi

1. Summary

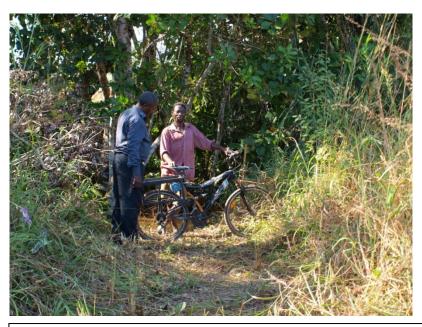
Mr Msiska (left) with a member of the irrigation scheme, beside the open water source used to irrigate the crops at Chandero village.

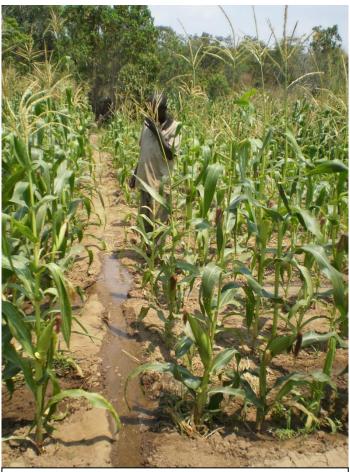
Official government scheme fed from a large dam in Limphasa EPA (supposed to be passive but secondary canals not working correctly)

Improvised canals used with buckets in Nkhata Bay EPA (active system)

For example, the control group of Limphasa EPA (a neighbouring district) was used to compare answers to Nkhata Bay EPA. The majority of the irrigation scheme members used paddy fields and gravity fed canals to grow rice, which was starkly different to the use of buckets and growing of maize found elsewhere so far. Although the interview answers the Limphasa rice growers gave were largely similar to other schemes, almost all of them had a strong preference for passive irrigation systems (like canals or solar pumps) rather than a tiring-to-use mechanical active system like pedal power or treadle pumps.
